47TH TURBOMACHINERY & 34TH PUMP SYMPOSIA
HOUSTON, TEXAS | SEPTEMBER 17-20, 2018
GEORGE R. BROWN CONVENTION CENTER

Case Study on investigation and resolution of Dry Gas Secondary Seal Failure

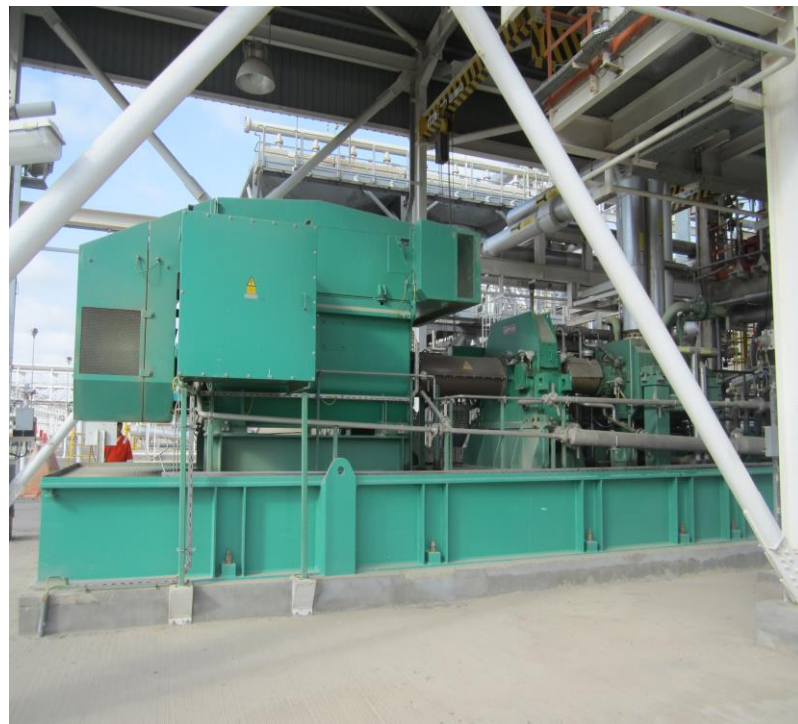
Machine Details

Flash Gas Compressor (Two stages) Electric Motor Driven

<u>Operating Data:</u>	<u>Stage 1</u>	<u>Stage 2</u>
Suction Pressure:	6.5 bara	20.4 bara
Suction Temp.:	55.5 deg C	49.9 deg C
Discharge Pressure:	21.28 bara	62.8 bara
Discharge Temp.:	139.4 deg C	142.5 deg C
Inlet Volume:	2740 m3/hr	781 m3/hr
Mol. Wt.:	29 kg/kmol	
Speed:	14853 rpm	
Train Power:	2010 KW

**Unit was installed & commissioned in 2012
but running in intermittent operation.**

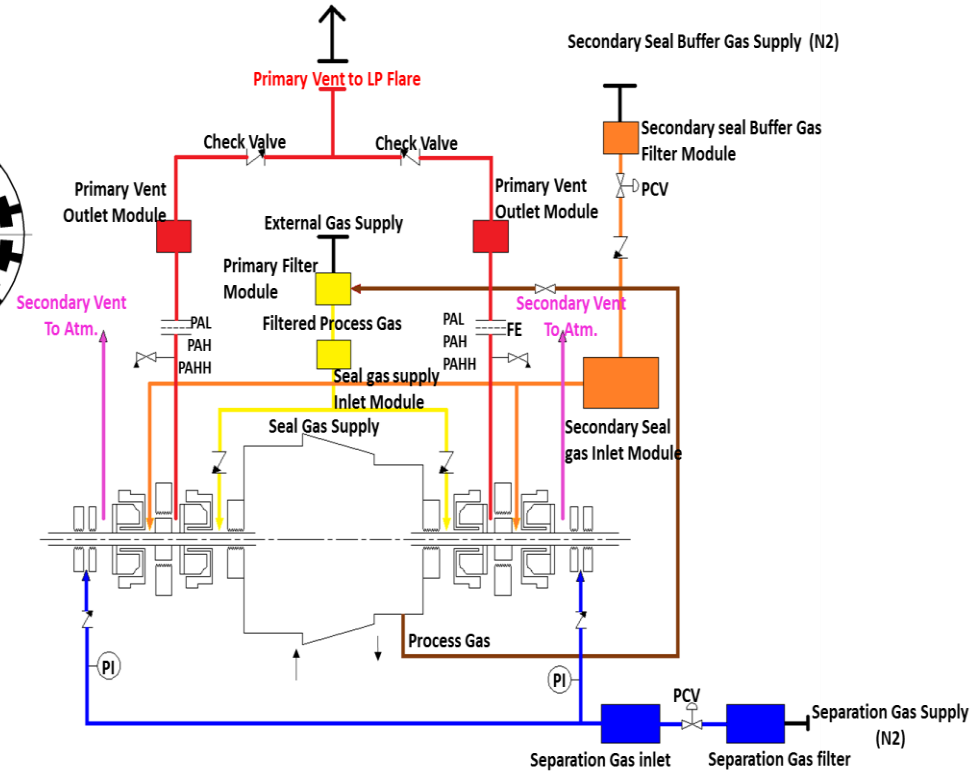
Dry Gas Seal System Schematic/Details

- Tandem arrangement with intermediate labyrinth.
- Bi Directional T-Groove Patterns.
- Seal Gas Heater to maintain seal gas supply temperature.
- Seal gas supply with 3um duplex coalescing filter assembly (Beta Ratio ≥ 200).
- Plant nitrogen being used as buffer gas for intermediate seal as well as separation gas for bearing housing.
- Buffer/Separation Nitrogen gas filtration with 3um duplex filters (Beta Ratio ≥ 200).
